Energy Efficient Florida Educational Facilities
Improvements to a Portable Classroom in a Volusia County School

FSEC-CR-1008-98*
June 1998

Michael P. Callahan
Danny S. Parker

Florida Solar Energy Center
1679 Clearlake Rd.
Cocoa, FL 32922-5703

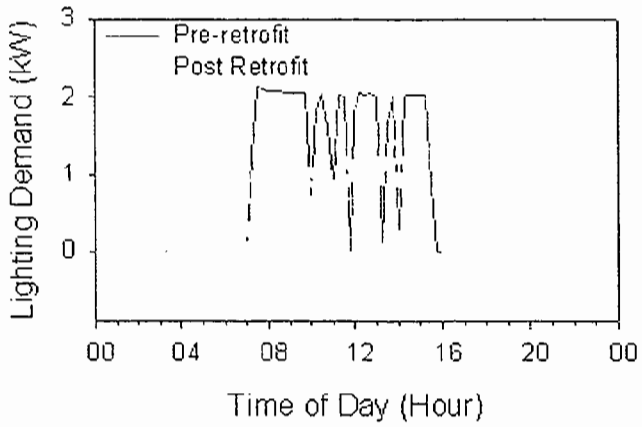
type of lighting system puts out a great deal of heat and is not as bright as the T8 lamps with electronic ballasts which they were replaced with. The old system also had greater energy consumption than did the new system as seen in Figure 2.

Figure 2. Graph of lighting demand over the course of a day for portable 035. Pre-retrofit average demand is 0.60 kW and post retrofit average demand is 0.45 kW.

The lighting energy comparison pre and post retrofit in Figure 3 highlights the energy savings. The average energy demand on May 20, 1998 prior to the retrofit is 0.60 kW while the average energy demand after the retrofit (May 27, 1998) is 0.45 kW. This represents a energy savings of 25%, which is higher than in previous studies (Sherwin and Parker 1996). This savings is considerable since the data shows that lighting energy for portable 035 is 26% for May 20 while on May 27 the energy use was only 19% of total portable energy use.

This is the concept behind retrofitting the lighting system in portable 035. The 24 fixtures in the with the old magnetic ballasts were replaced with 12 electronic ballasts. The F40CW T12 lamps were then replaced with F32 T8 lamps.

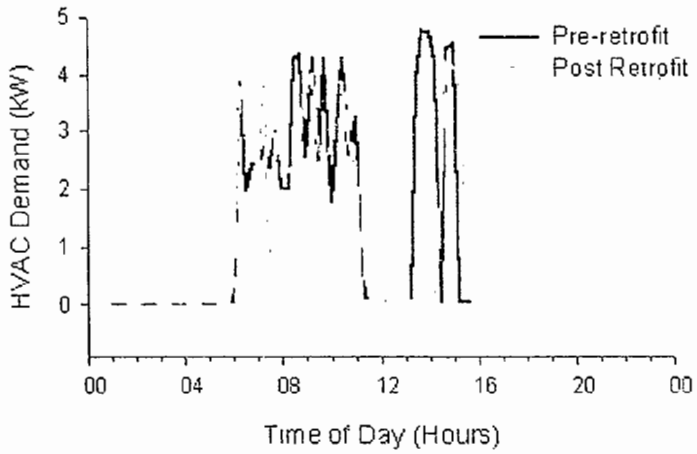
the pre-retrofit temperature, but that the total energy use by the AC system is 2.8 kWhs less (14%), even though the Bard unit is a 2.5-ton unit versus 3 tons for the old unit. Figure 6 also points out that through the hottest part of the day, the demand post retrofit was approximately 500 watts less than pre-retrofit.

Figure 5. AC energy demand data for two matched days. Pre-retrofit total kWh = 22.4: post retrofit total kWh = 19.6

On June 17th the existing Cripsaire AVP36HPA wall unit was replaced with the new 2.5-ton system with an energy recovery ventilator. It would be premature to attempt to analyze data from the AC retrofit, due to the school year ending before the recent installation. With the end of the school year and the subsequent install, the AC has either been turned off altogether or the schedule has changed significantly. When school resumes in late August and the AC is once again run for most of the day, a savings analysis can be performed. Figures 5 and 6 examine preliminary data for this retrofit. This data has been gathered from two matched days with very similar outdoor temperatures.

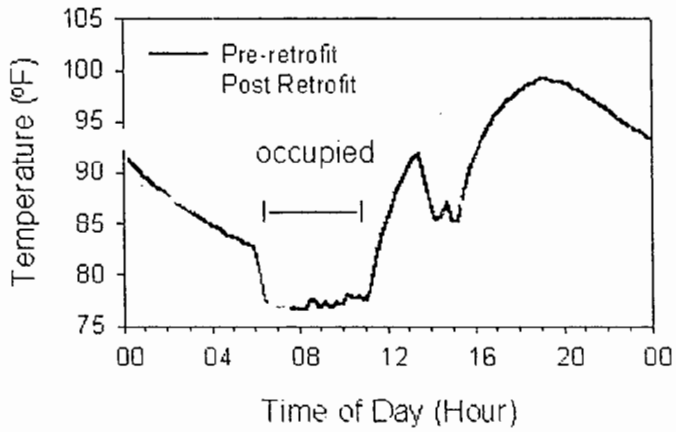
It can be seen that the average temperature within the portable post retrofit is very similar to

Figure 6. Interior air temperatuers for two matched days. Pre-retrofit average temperature –

88.09: post retrofit average temperature = 88.13
